# FACET Summary      May 4 - 10

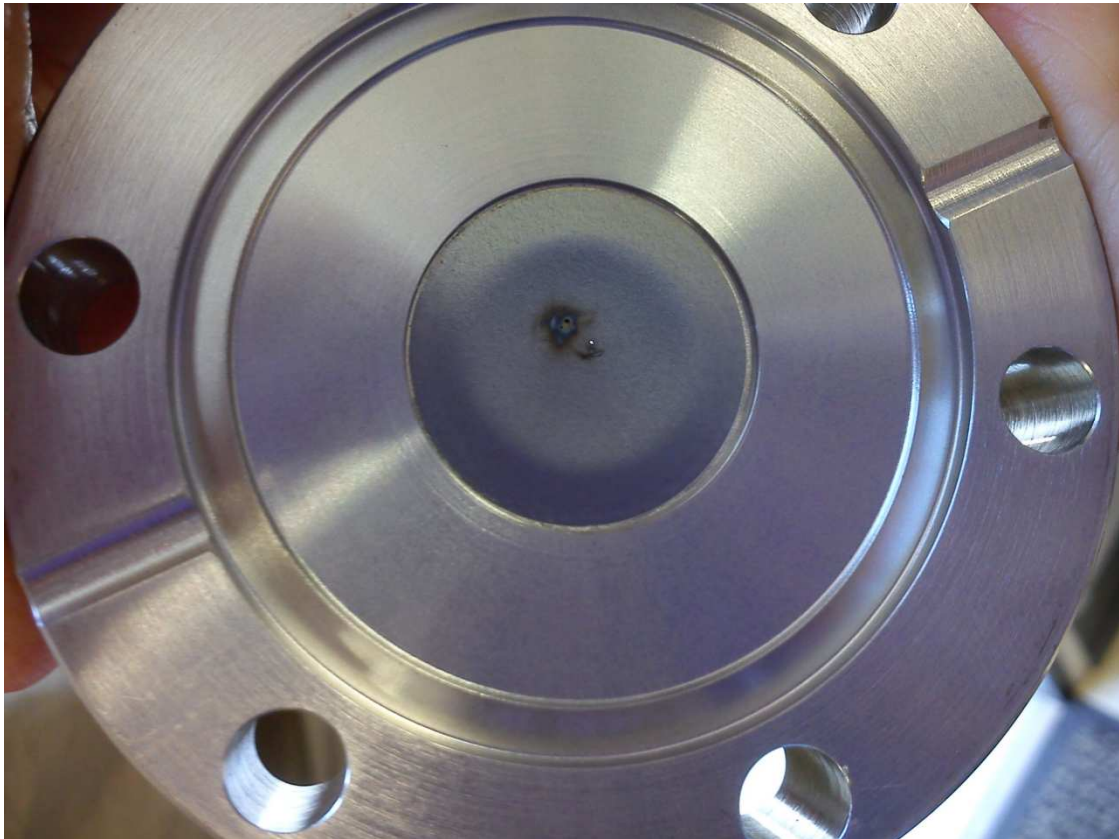
- Fri 10<sup>th</sup>
  - Find a pressure leak in the plasma chamber vacuum region. The buffer gas is He and there is a pressure rise in the downstream Kraken chamber. Suspect a crack in the 75  $\mu\text{m}$  thick downstream Be window. Access to vent and replace the Be window. Exchange complete by end of day shift. Machine recovery good with emittances the same as before the access.

- Picture of the Be window. There are several marks. The bright spot is the location of the hole. A light is shining through from the other side. Machine recovery again is good with IP spots sizes at the WS2 of 33x26  $\mu\text{m}$  by 18:00.
- E200 data taken all night.
