Technical Note	
	Title: LCLS-II HGVPV Controls Issues Encountered	
	Note Number: LCLSII-TN-18-04	
	Author(s): Ken Lauer	Page 1 of 16

This document enumerates past and present HGVPV control issues up until the time of writing. Issues prior to the controls FDR in February 2017 are not included.

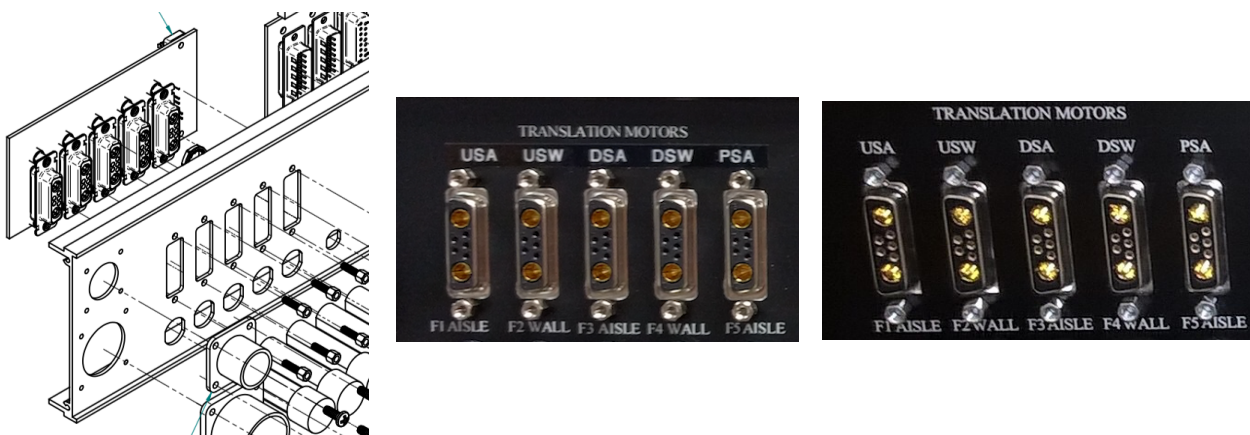
- Gap control fails despite all limits and interlocks being in working order
- SmartMotor LEDs remain yellow
- SmartMotor communication failure in IOC console
- Intermittent motion failure

An initial set of SLAC-built UCMI-2 chassis were made for the planned 7 test stands for SLAC and the vendors. These initial chassis had D-Sub 7W2 connectors with recessed 1mm diameter pin receptacles. Combined with the large mating connector back shell and recessed receptacle mounting on the UCMI-2, this caused intermittent connectivity of the essential motor controller RS-232 serial signal.

Figure 1. Left to right: Rear panel motor PCB assembly diagram portion, problematic UCMI-2 translation motor section, and fixed section of the production UCMI-2 chassis.

The source of the problem has been determined and a fix is underway. A plan has been made to replace the affected PCBs in the original 7 test-stand UCMI-2 chassis. Cable connector backshells have been replaced. The production UCMI-2 chassis are unaffected as a different and better connector was sourced for the production run. These production chassis have been used as temporary replacements for the test stands:

- Replacement production UCMI-2 was shipped to Keller in July
- Replacement production UCMI-2 was shipped to Motion Solutions in July by LBNL, SLAC to replace in August
- SLAC long-term test stand, floating test stand, and MMF test stand have had UCMI-2 replaced
- Replacement PCBs with the production connectors were ordered in May.

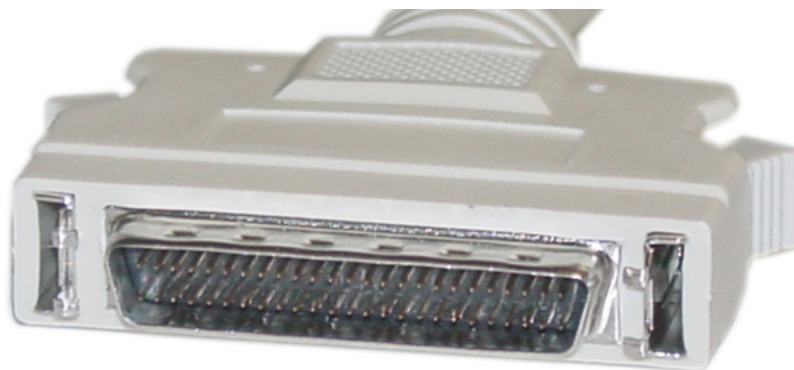
- Limit switches fail to read appropriately, disallowing motion
- Motor communication does not work
- System is in an unrecoverable state

The high-density SCSI-2 connector has 50- 0.8mm pins which are very fragile and prone to bending if even slightly misaligned when inserted in the UCMI-1 or UCMI-2. Compounding the issue, the chassis back panels are recessed in the rack, are surrounded by many other sturdy cables, and are rather difficult to access.

Figure 2. Male SCSI-2 50-pin connector.

- Vendors have been apprised to carefully connect these cables, and inspect when initial setup issues occur
- Multiple spares have been purchased of the current cable
- Preliminary work has been done to investigate a sturdier replacement. Stand-offs and new cables will have to be purchased to mitigate the issue altogether.

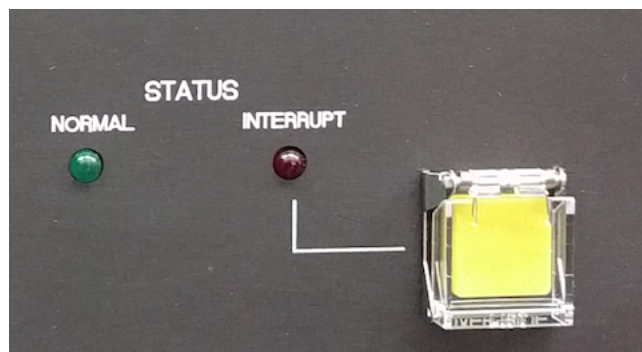
- No power coming from UMPI chassis
- Supply LEDs are off; motors do not move

Figure 3. UMPI bypass push-button.

Rapidly pressing the UMPI bypass pushbutton (located under a plastic flip-cover) causes one of the fuses in the UMPI chassis to blow.

This has been deemed something that should be taught to users of the system. This will not be fixed with a modification to the UMPI chassis.

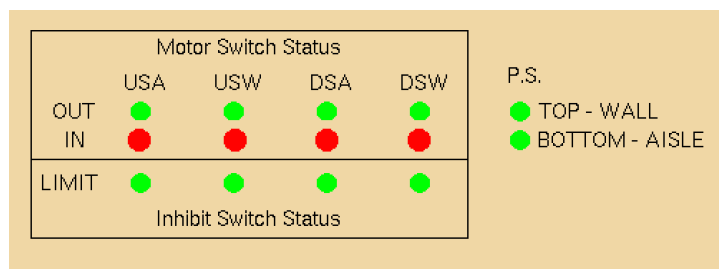
- FPGA denies requests to close the gap, though no physical limit is actuated

Figure 4. The result in the user interface when a UCMI-2 status cable is made incorrectly. Note that all gap closing motion is inhibited, though no limit switches are reportedly actuated.

After lengthy debugging procedures and cable verification, the cause was determined to be improperly assembled 4-pin LEMO cables. The design of these connectors is such that the alignment red dot on top should be in the same location as the alignment key inside the connector. However, there is a failure mode

Knowing the symptoms, this issue is now significantly easier to debug for the test stands. For installation, the cables will be verified prior to the 1-year shutdown.

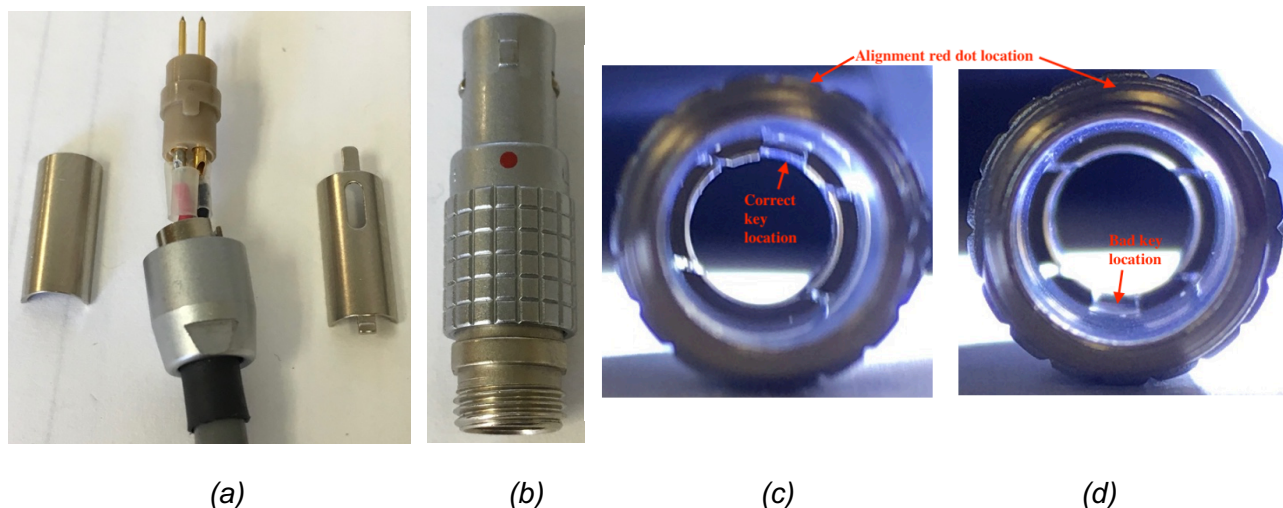
in which it is possible for the inner key to be moved 180 degrees outside of the correct position (see figures below).

Figure 5. 4-pin male LEMO connector FGG.0B used for interlock status signals to the UMPI. (a) Cable and pins (b) the problematic connector (c) a correctly keyed connector (d) an incorrectly keyed connector.

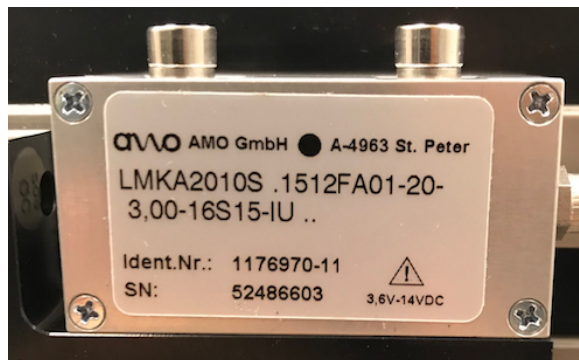
- Full-gap encoder readout on user interface is not updating
- Full-gap encoder on user interface is not scaled correctly

Remote support of LBNL's full-gap encoder usage drove debugging the functionality as their usage became a requirement. Miscommunication regarding model numbers (the manufacturer AMO had recently been acquired by Heidenhain and changed all model numbers at this time) caused several issues with scaling.

Figure 6. The correct full-gap encoder readhead model (LMKA-2010S.1512FA01-20- 3,00-16S15-IU).

With the correct model number, the correct scaling factor is now in use (28 data bits, 1 warning, 1 error, 1 even parity bit; 250nm resolution). This functionality can be utilized at any facility requiring it after the IOC changes are migrated.

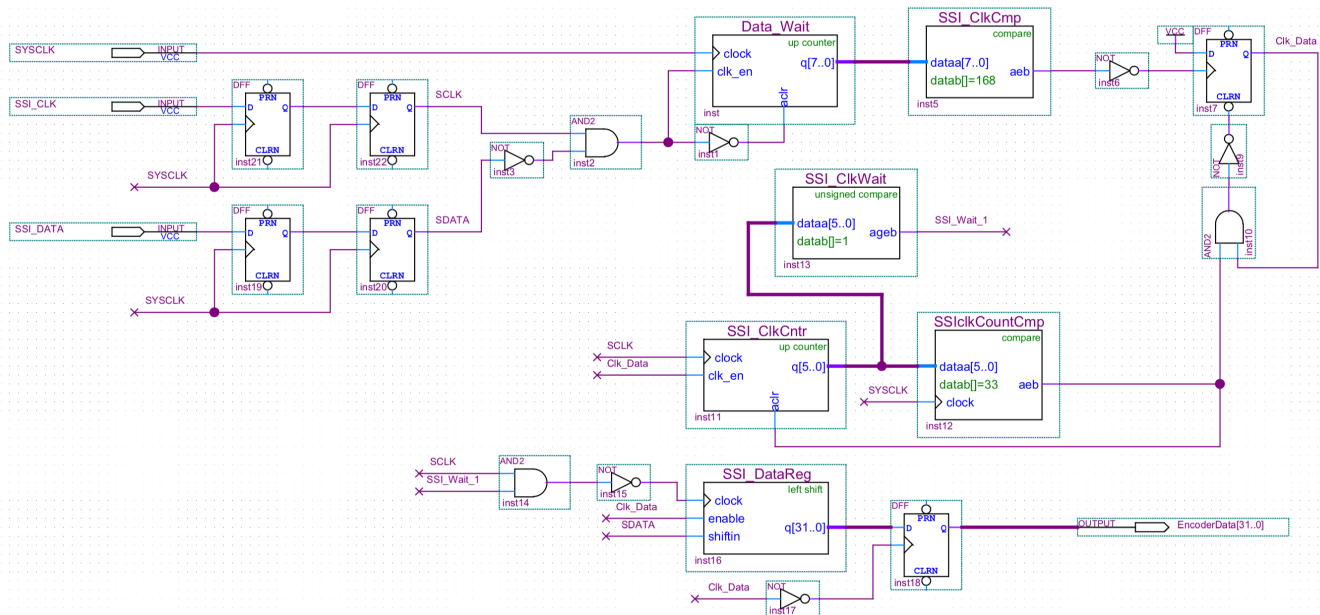
- FPGA read-out of encoder did not match up with that of the commercial SSI encoder reader
- FPGA skew and asymmetry trips unexpectedly reported

Comparing the read-out of both encoder read-out electronics led us to doubt the FPGA implementation, originally done by hand in a block-schematic style. Monitoring the position at a fast rate with EPICS confirmed that the implementation was indeed faulty.

Figure 7. The faulty SSI encoder readout FPGA implementation.

The functionality was re-implemented in VHDL, included in the current FPGA firmware. It has been working flawlessly since.
